Inspection Report

Minerals Regulatory Program

Mine Name: Torrey Buff
Operator Name: Quality Building Stone

Permit number: S0550022
Inspection Date: May 12, 2008
Time: 4:55-5:10 PM

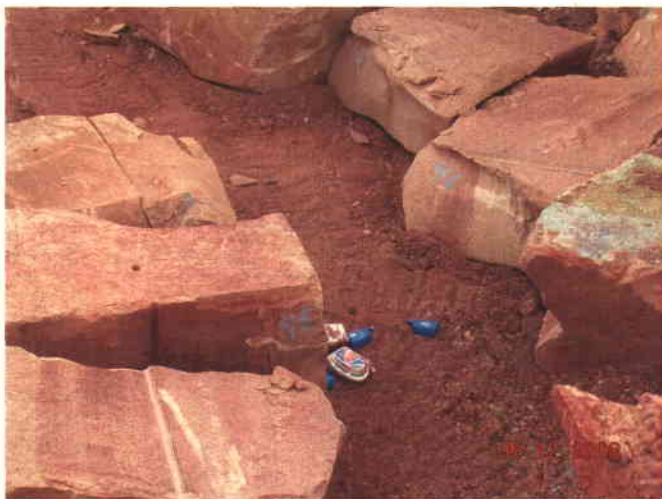
2. Public Safety (shafts, adits, trash, signs, highwalls)
I found some old tires, oil containers, and a battery.

Photo 1. Some of the trash that needs to be cleaned up.

The trash, i.e. tires, oil containers, and battery, need to be cleaned up.

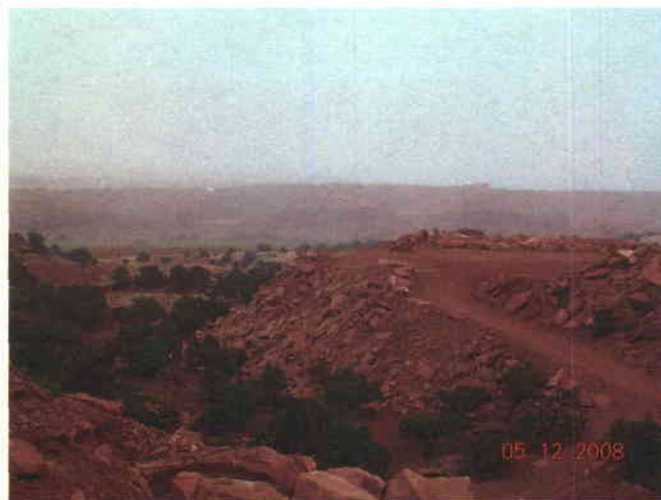
Photo 2. The outslope shown in the center of this picture is one of the areas that was to be seeded, but because of the rocks, I don't think it will be possible to do any surface preparation.

The surface should be scarified and left rough, and seeding should be done almost immediately after surface preparation. This should be done in the fall. Surface preparation will be impossible in areas mostly covered by rock.

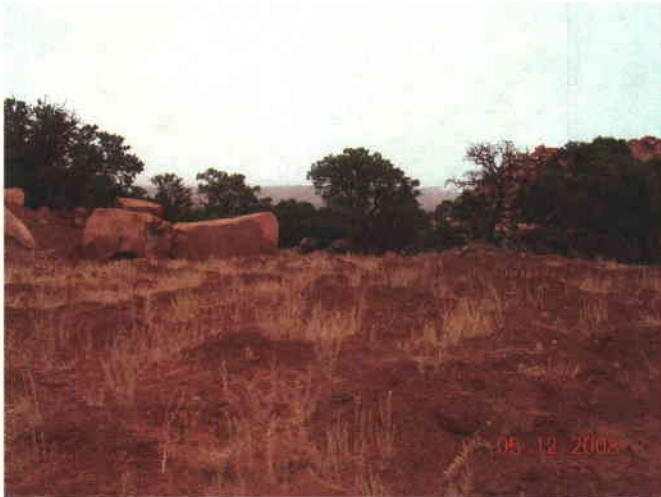
The Division's acceptance letter of January 19, 2006, contained a provision that certain areas be seeded in the fall of 2006. I understand from the operator this seeding was done, but I saw no signs of vegetation establishment. Some of the seeding may have been done in the spring, and this may be part of the reason for the lack of establishment. I am also not sure how well the soil was prepared before seeding.

Photo 3. This area appears to have been reseeded, but the plant skeletons are weeds.

The areas that are not going to be used again for the quarry operations need to be seeded again. I suggest that the operator contact the Division before any seeding is done so the methods can be documented.

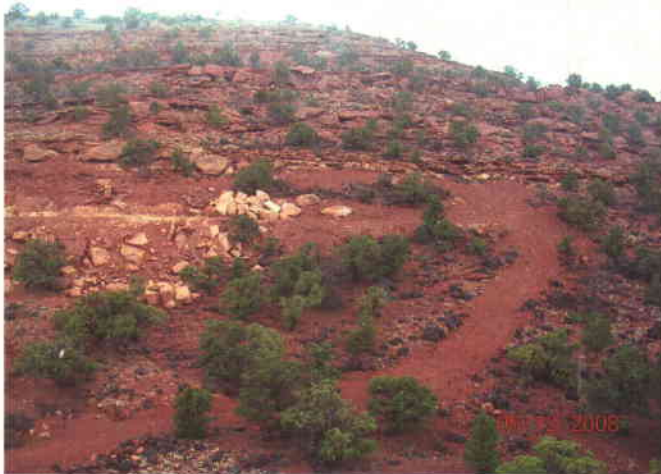
Photo 4. The road going up the hill toward the right side of this picture is one of the areas that was to be reseeded, but I saw no signs of vegetation establishment.

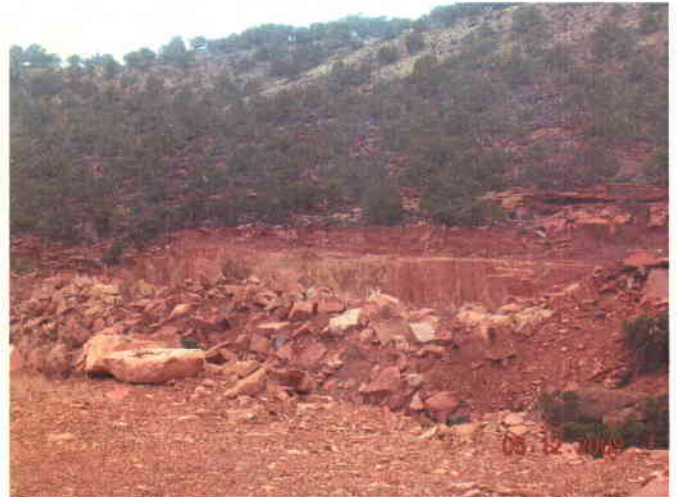
Photo 5. This is a highwall that was backfilled.

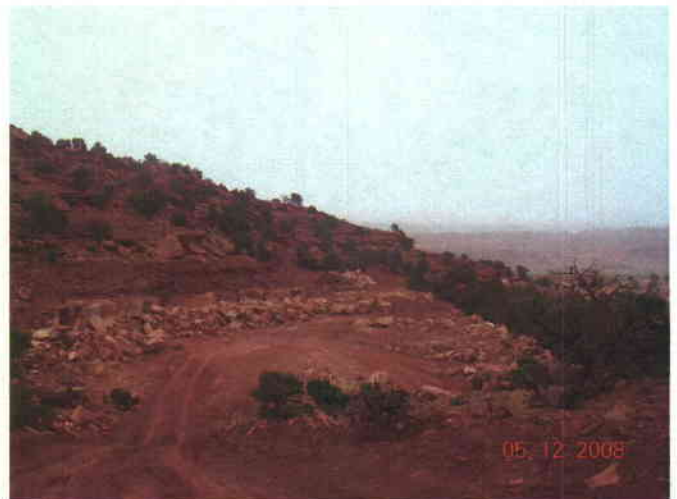
Photo 6. The road shown in this photo is still being used, but the operator is not quarrying in this area.
